Shaving errors and their causes

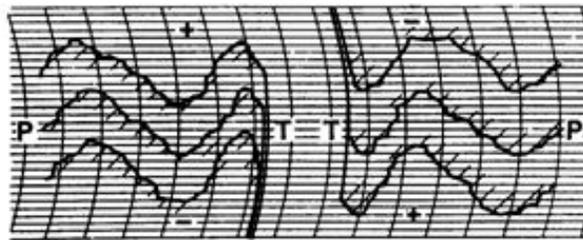
Profile with sinusoidal trend

If the profile error of the gear before shaving is not too big and the sinusoidal trend after shaving remains even after having varied the cutter rotation speed and speed, the cause of this defect has to be searched in the wrong designing of the cutter. It is very likely that the even contacts condition is not fulfilled. See figure N°1.

Fig.N°1- Profile error generated by the non fulfillment of the even contacts condition

Unfortunately, anyway, in some instances even if the shaving cutter is correctly designed, this error remains. You can go and read again what we stated for the limits of the even contacts. In these cases the only way out is to modify the cutter profile in the opposite sense of the error generated on the profile; quite often you can get the profile right after a few trials.

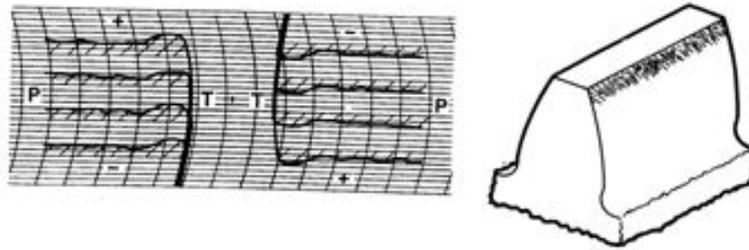
Tooth with material at the tip

The cause is a too high cutting speed V_s (component in radial direction) or a too narrow cross of axes angle.

If the rotation speed is too high, the direction of vector V (total cutting speed) close to gear outside diameter will be oriented too vertically and the cutting would not be very effective. See figure N°2.

Fig.N°2- Excessive material at tooth tip with presence of stripping

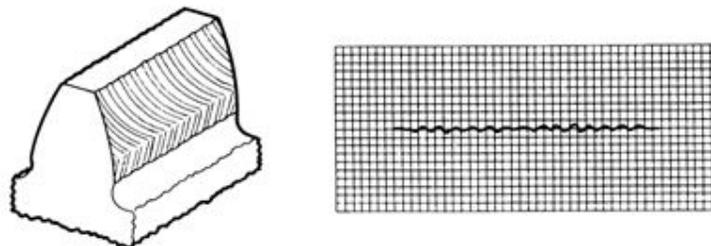
Serrations traces are too evident on the gear

The malfunction is due to the fact that for each revolution of the gear to be shaved you have a shifting of the contact between cutter and gear equal to the pitch of serrations. It is sufficient to modify the shaving cutter leaving unchanged the feed speed: in this way you have a different orientation of the cutting direction and an improvement of the surface. You can also try to alter the feed, leaving rotation speed unchanged. See figure N°3.

Fig.N°3- Traces of serrations on tooth shaved surface

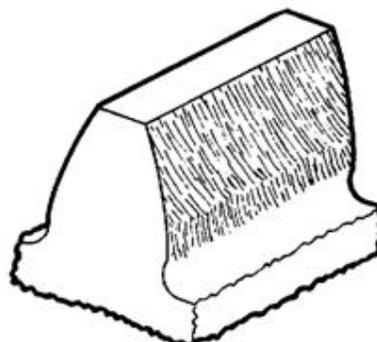
Gear has a lot of burrs and teeth surfaces have a slightly striped and glossy look all along the tooth length

This defect is due to shaving cutter wear or to an insufficient cross of axes. For this last case it is necessary to increase as much as possible the longitudinal feed speed V_a .

If the cutting edges are too rounded they can no longer "bite" the material and they do not produce a regular chipping.

You find sliding movements that, occasionally, produce a glossy appearance on the shaved surface, upsetting part of the material that has not been cut towards the outside diameter. See figure N°4.

Fig.N°4- Noticeable burrs on the teeth and partially glossy surface

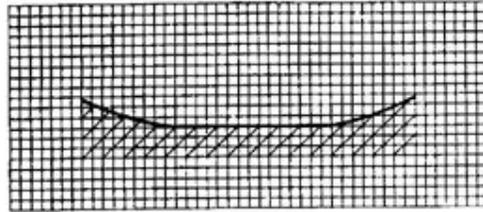
Helix is hollow

This error is due to insufficient table stroke length.

In plunge shaving, instead all this is caused by a wrong shaving cutter resharpening.

The point of contact in the parallel or diagonal shaving does not start and ends in a correct way. See figure N°5.

Fig.N°5- Hollow helix

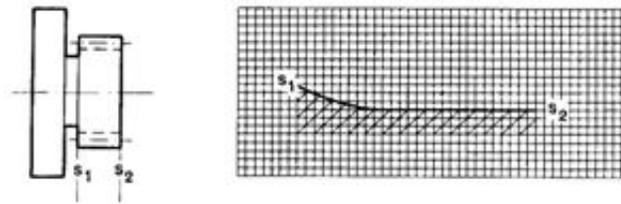
Shaving stock close to a shoulder on a tooth flank has not been completely removed

This malfunction is nearly surely due to a too short table stroke on the side of the shoulder or to a wrong cutter setting.

Fig.N°6- Excessive material on helix close to a reference face

You can get rid of such inconvenient by adjusting the stroke correctly . See figure N°6.
