Anomalies in the use of hobs and solutions

In this article the anomalies that may arise during hobbing are summarised and possible causes and remedies are given.

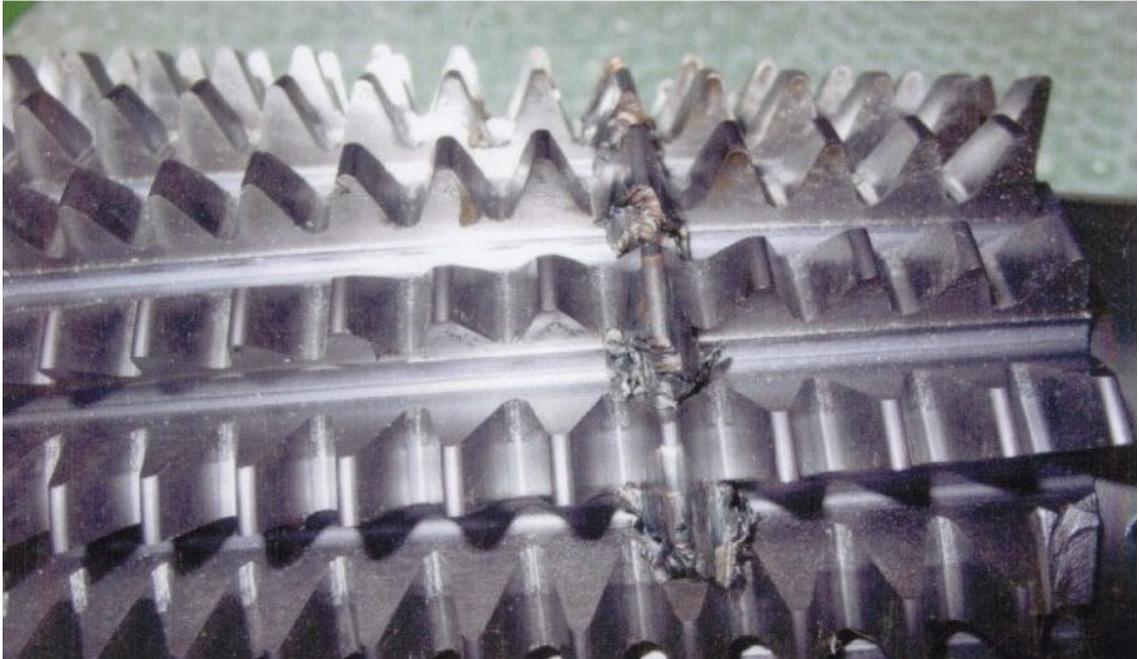
Figure No.1

- Blockage of chips in the grooves. In general it is possible to identify grooves which have been blocked by chips even on a broken hob. (see fig. No.1)
